64 EXTRA CARE FLATS BESPOKE WI-FI INSTALLATION

This social housing development spanned over three floors, with 64 extra care flats for 69 tenants. Providing sufficient Wi-Fi coverage was of the utmost importance in the design and installation process. We aimed to provide tenants the ability to roam between communal areas and stay connected to the Wi-Fi. We were able to achieve this with our bespoke services.

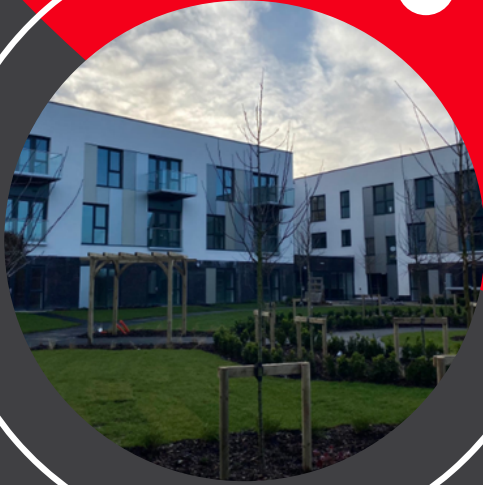
- The first step was a site survey: where we liaised with the client & the contractors to go through and assess the existing data cabling on site.
- This was followed by Wi-Fi design which involved: uploading the floor plans onto our design software, scaling the plans and drawing the building and inputting all attenuation areas such as walls, doors, electrical appliances and furniture etc. Then we created Wi-Fi coverage heat maps for the communal and staff areas.
- A channel and power plan for 2.4 & 5Hz to avoid CCI was also created alongside a capacity plan to ensure the wireless capacity is sufficient for all tenants to connect concurrently.

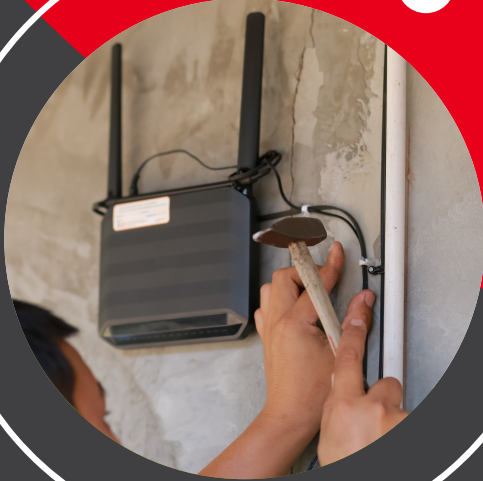
- **The next step was the installation:** All data cabling was in place and ready for us to install our access points and set up the network room
- **We returned at the second fix stage to:** install and commission the fibre broadband service and install a firewall, POE switch and controller into the network cabinet. We terminated and tested the network cabling to be used for the Wi-Fi access points. The Wi-Fi access points were then mounted into the ceiling voids and the Wi-Fi network was configured. There was final testing from all areas before we provided log on details for the tenants.
